SERVICE No. 1005 BULLETIN

Addition of Drain Holes to the Engine Induction Air Inlet Scoops

PA-28-181 Archer III
PA-32R-301 Saratoga II HP
PA-34-220T Seneca V

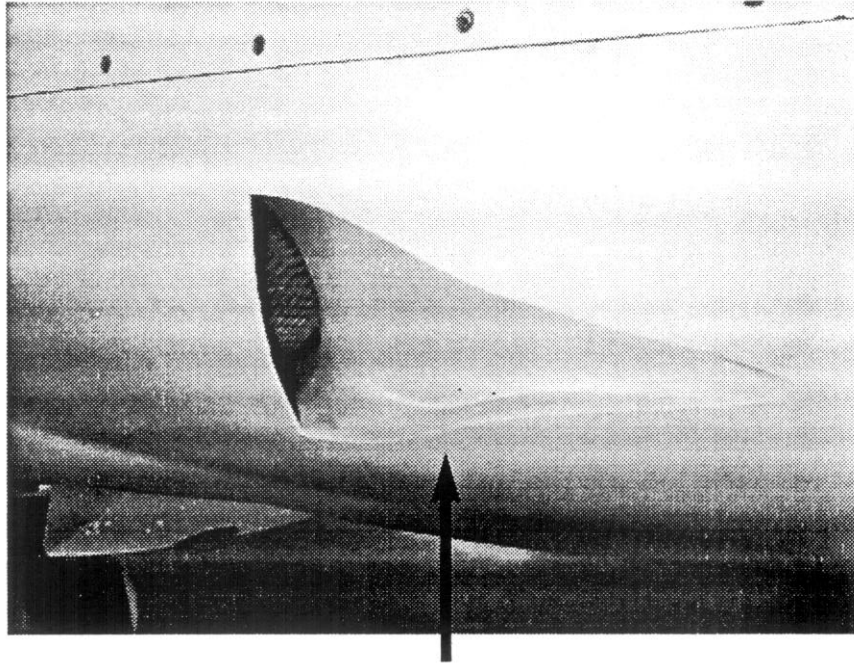
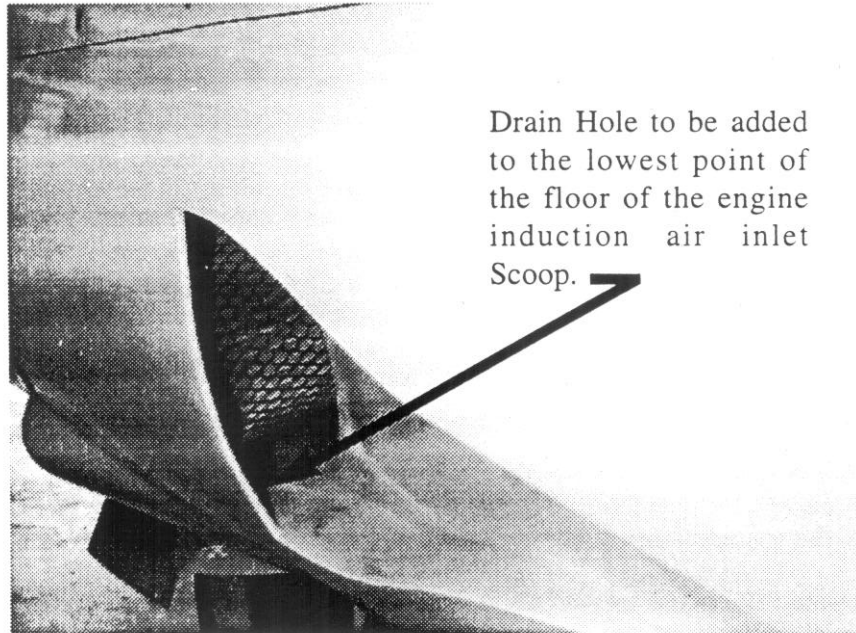
FIG. 1

It has been discovered that the axisymmetric cowling incorporating a NACA style engine induction air inlet scoop may retain water in the lower portion of the scoop cavity. To provide for proper water removal a drain hole must be placed in the bottom of the scoop. Left uncorrected, the engine induction air inlet filter and scoop housing may become damaged through the formation of ice.

Typical NACA Engine Induction Air Inlet Scoop
(Seneca V shown, Archer III and Saratoga II HP similar.)

1. Locate the NACA engine induction air inlet scoop on the right side of each Seneca V engine cowling, and on the left side of the Archer III and Saratoga II HP. (See Fig. 1.) Remove the upper cowl(s) to access the air filter assembly.
2. Remove the air filter assembly to access the inlet air scoop housing.

- At the point marked in instruction 4 above, drill a .25 hole. Fill the .25 hole with aircraft quality fiberglass resin and allow to cure. Obtain fiberglass resin locally. (Cure times may vary, consult resin manufacturers recommendations.)
- In the center of the resin filled hole drill a .191 drain hole. Smooth the hole edges as required.
- Clean the engine induction air inlet scoop thoroughly of all debris and install the air filter assembly. (*Remove from jacks if used to level aircraft previously.*) Perform an engine ground run to check for security and operation of the air induction system.
- Re-install the upper cowling.
- Make an appropriate airframe logbook entry of compliance with this Service Bulletin.
