The New Piper Aircraft, Inc.
2926 Piper Drive
Vero Beach, Florida, U.S.A. 32960

SERVICE No. 1011 BULLETIN

**Inspection and Replacement of the Aileron
Inboard Hinge Nose Rib Nutplates**

PA-32-301 Saratoga
PA-32-301T Turbo Saratoga
PA-32R-301 Saratoga SP
PA-32R-301T Turbo Saratoga SP
PA-32R-301 Saratoga II HP
PA-32R-301T Saratoga II TC

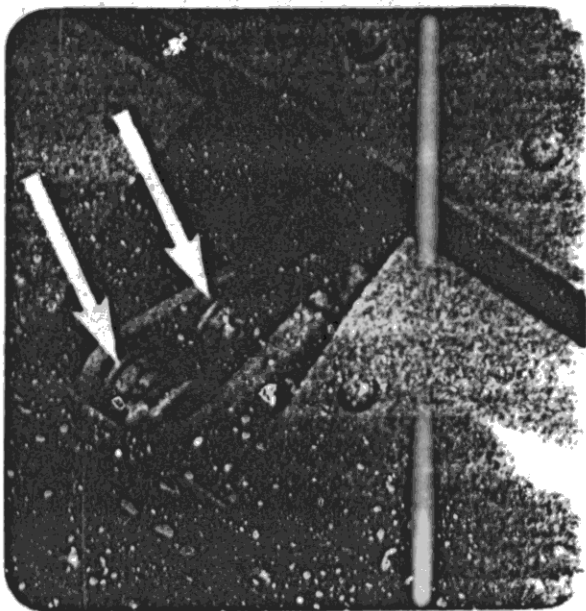
FIG. 1

Inspect for lock nuts. If installed, no further action is required. Make an appropriate logbook entry of compliance with this Service Bulletin.

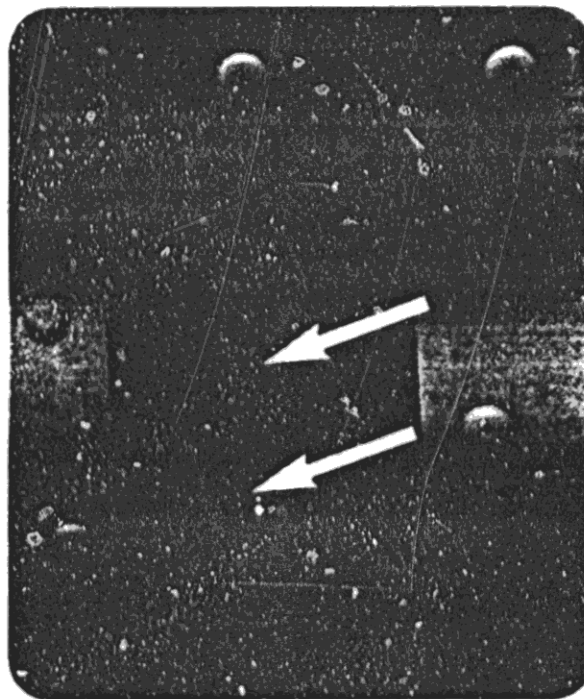
FIG. 2

Inspect for bolt heads. If there is no evidence of nutplates being installed, further action is not required. Make an appropriate logbook entry of compliance with this Service Bulletin.

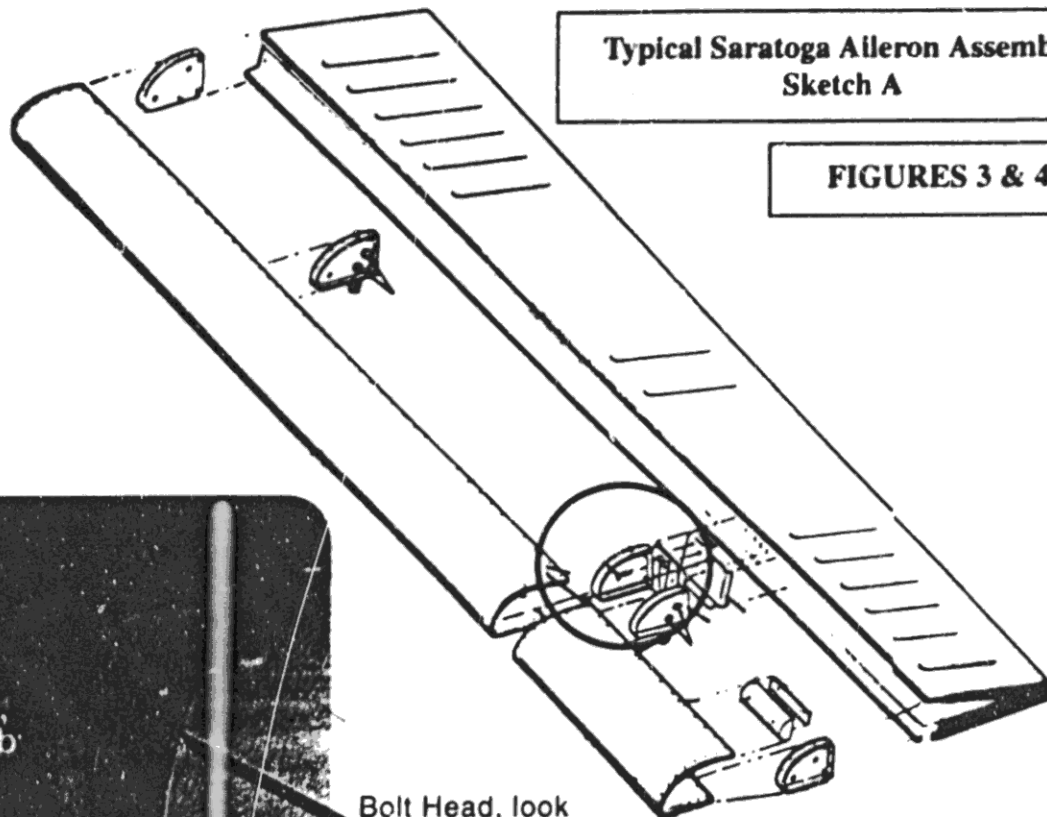
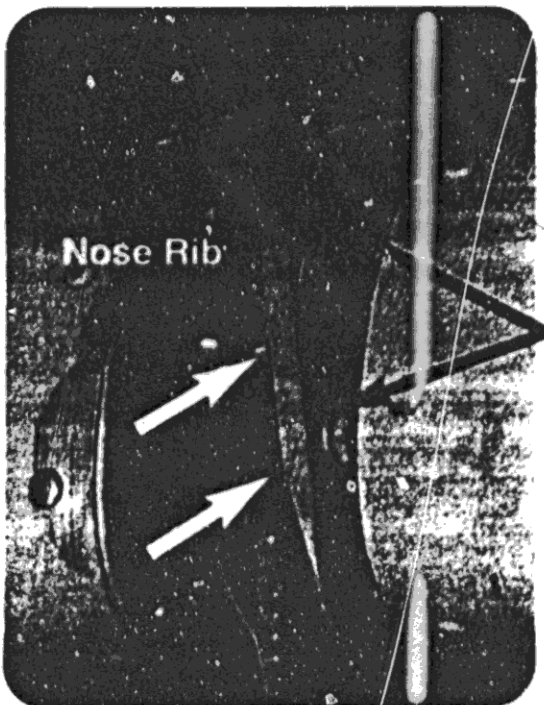
FIG. 3

It has been discovered that the nose rib for the aileron inboard hinge may crack around the nutplates used as fasteners to attach the hinge fitting. Evaluation of these cracks has indicated that the sharp corners of the square ended nutplates initiate the condition. Cracks may be detected externally through repetitive inspection. Left uncorrected, this condition may result in the impairment of the aileron inboard hinge.

Look for cracks appearing from under the hinge fitting.

Bolt Head, look for nutplates.

7. Remove the hinge fitting from the nose rib. Gain access as required and remove the nose rib.
8. Examine the area around the existing nutplates for visible cracks. Figure 3 and 4 point out the general area where cracks may appear. If cracks are found replace the nose rib and install two new Piper Part Number 406-825 nutplates on the new nose rib. (See material required below.)

9. If no cracks are apparent, remove the existing nutplates and perform a dye penetrant method inspection on the rib to be sure no cracks exist. If no cracks exist, install two new Piper Part Number 406-825 nutplates on the existing nose rib. (Nutplates are fastened with MS20426AD3 countersunk rivets, obtain locally.)
