Piper Aircraft, Inc.
2926 Piper Drive
Vero Beach, Florida, U.S.A. 32960

SERVICE BULLETIN

NO. 1242

RUDDER PEDAL ASSEMBLY INSPECTION

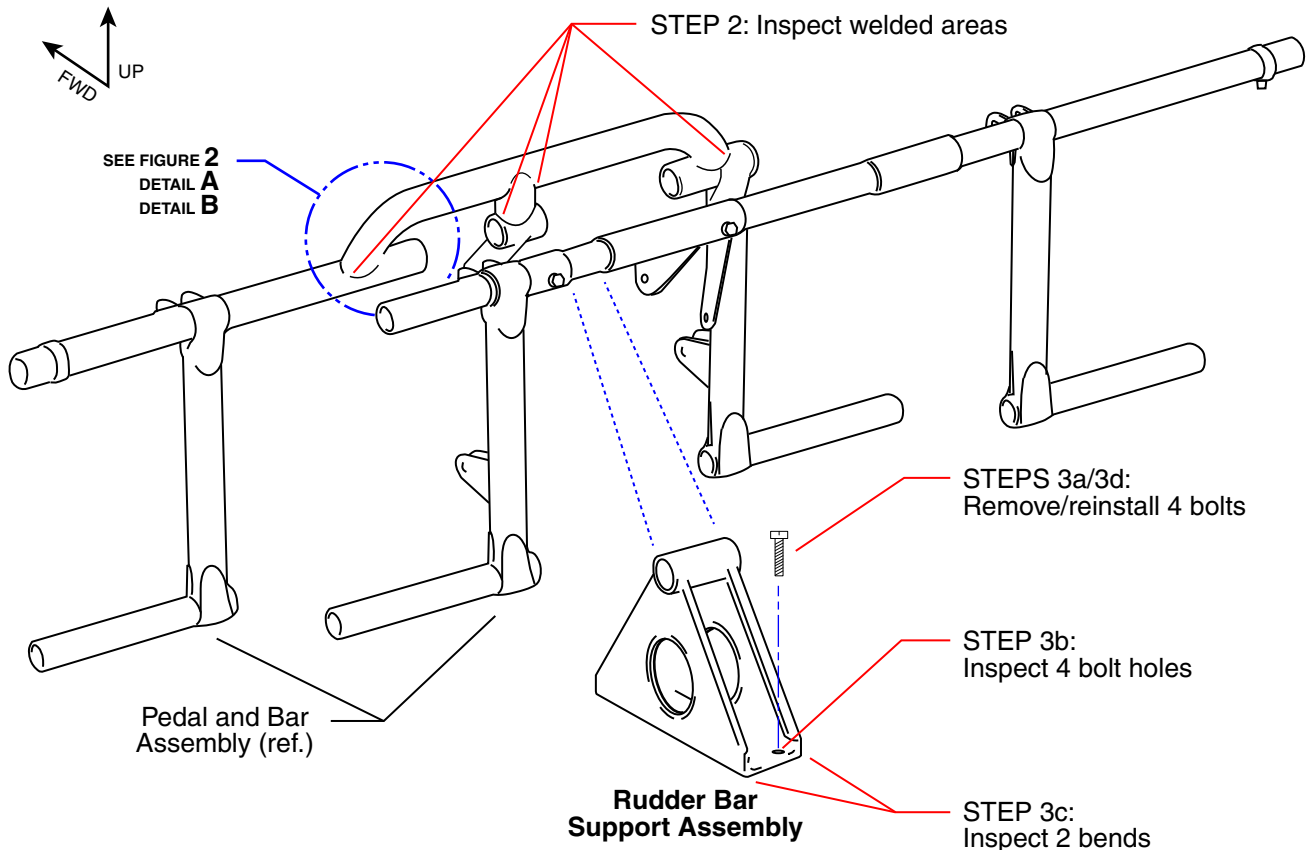
Figure 1
Rudder Pedal Installation (Typical)

Visually inspect all welds, with specific emphasis on the locations identified in Figure 1.

- b. Visually inspect the four (4) bolt holes for cracks and elongation. See Figure 1. The diameter of the four bolt holes should measure 0.250 +0.005/-0.001 inches.
- c. Visually inspect the two (2) sheet metal bends common to the base for cracking, the entire length of each bend, both inner and outer surfaces. See Figure 1.
- d. Reinstall the four (4) bolts that secure the rudder bar support assembly to the cockpit floor. Refer to the appropriate section or chapter of the applicable Piper maintenance manual for the required installation torque for threaded fasteners.

NOTE: Any cracked components must be replaced prior to next flight.

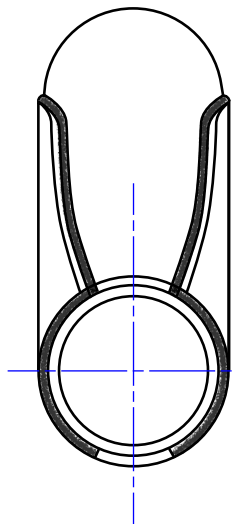
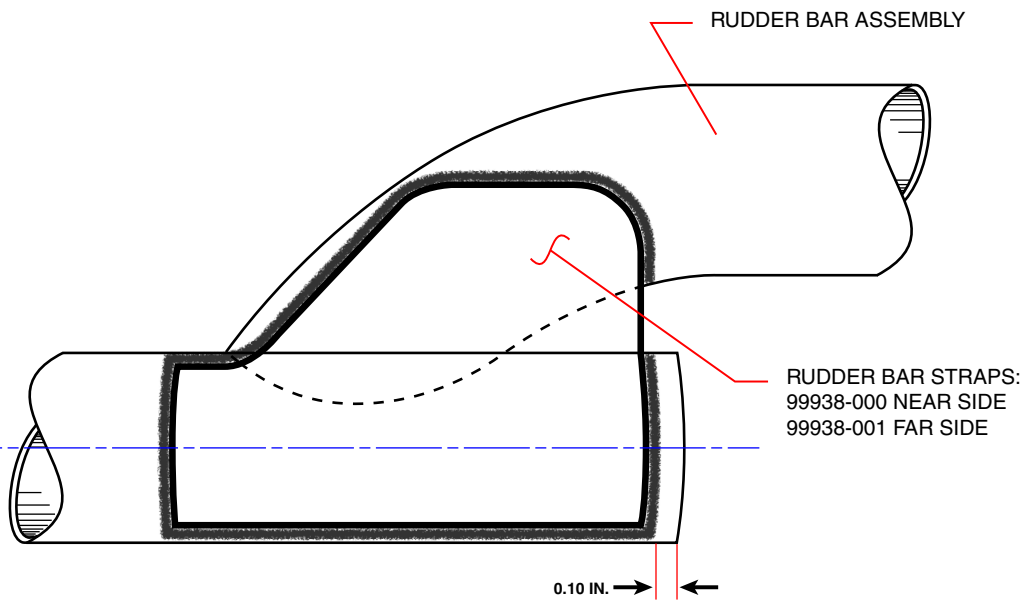
DETAIL B

NOTE: All new replacement rudder bar assemblies conform to the configuration shown in Detail B. At the operator's discretion, a new replacement rudder bar assembly may be installed in lieu of the modification described below.

- Examine the area to be modified for cracks, using the inspection criteria described in Part II. Any cracked components must be replaced prior to proceeding.
- Order one each of Piper part numbers (P/N) 99938-000 and 99938-001 rudder bar straps. TIG weld in place as shown in Detail B, per Chapter 4 of AC 43.13-1B (or latest revision). After welding, relieve residual stress in the affected area: Heat with a non-carburizing torch flame to 1,000°–1,100° F (538°–593° C) (a brown red color) then air cool to room temperature. All welding must be performed by a certified welder.

- All materials are 4130 normalized steel.
- The rudder bar tubes have a nominal outside diameter of 0.875 inches and nominal wall thickness of 0.058 inches.
- P/N 99938-000 and 99938-001 rudder bar straps are made from sheet steel with a nominal thickness of 0.040 inches.
