SERVICE BULLETIN

No. 703

Piper Aircraft Corporation

Subject: Aileron Balance Weight Attachment
Inspection and Rework

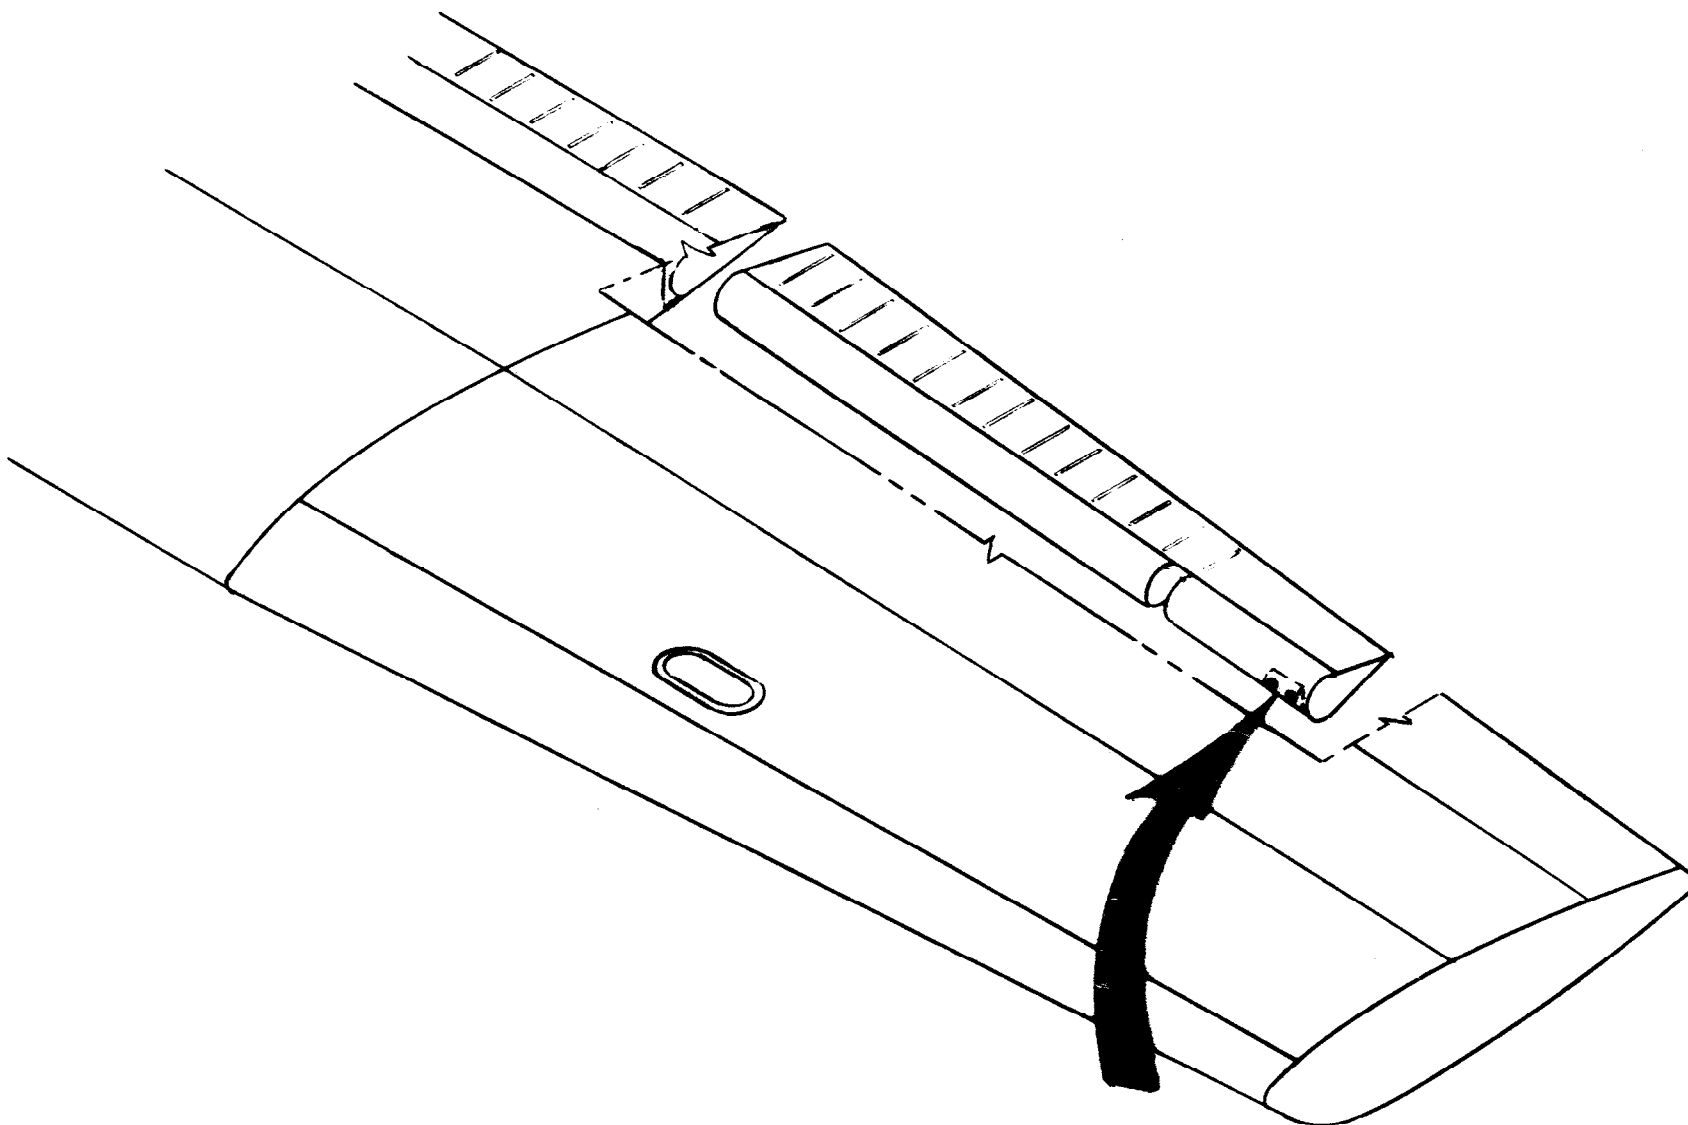
Reports have been received of aileron balance weights becoming loose in the outboard leading edge of the aileron. The balance weights are attached to the outboard leading edge skin with two (2) machine screws and the skin may have cracks propagating near them.

INSPECT IN THIS AREA FOR CRACKS
ON LEFT AND RIGHT AILERONS.

1. Check the left and right aileron outboard leading edge skins for cracks near the balance weight attachment screws.
 2. If skin is cracked around either balance weight attach screw, proceed to PART II of this Service Release.
 3. Make logbook entry of each inspection.
-

1. All instructions necessary to reinforce the aileron outboard leading edge skin are included in the Aileron Rework Kit, Piper Part Number 764 091V.
-
