# SERVICE No. 927 BULLETIN

SUBJECT: Hartzell Service Bulletin No. 164,  
Inspection for Cracks in Certain  
Two Blade "Y" Shank Aluminum  
Propeller Hubs

SERVICE BULLETIN 164  
 CODE: C

**Inspection for Cracks in Certain Two Blade "Y" Shank Aluminum Hubs**

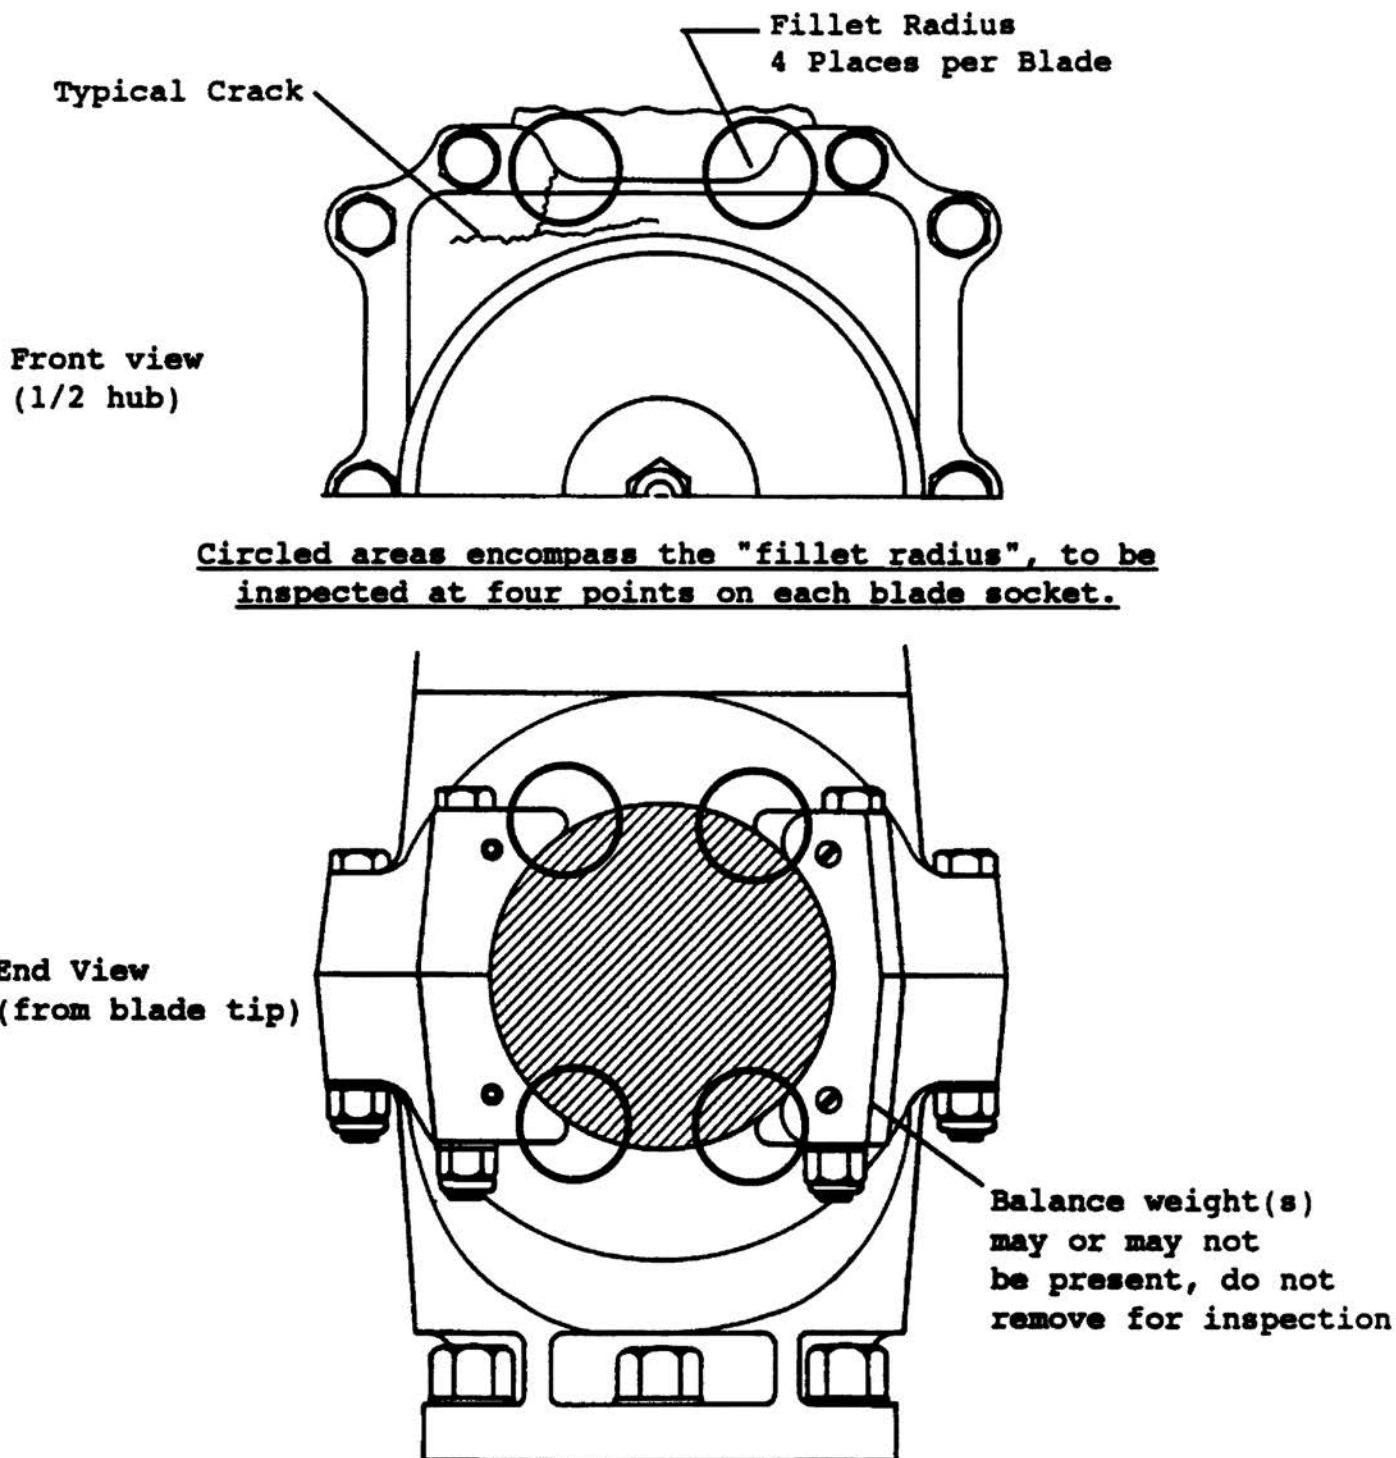
**Figure 1. Hub Fillet Radius**

Cracks typically initiate at the same point on the hub. The cracks are external and believed to be observable with careful visual examination. The cracks originate at a point adjacent to the blade called the "fillet radius". As the cracks propagate toward the center of the hub, their progression accelerates and results in failure of one hub half which can then, potentially, progress to blade separation.

**NOTE:** Typically, cracks begin at the outermost point and propagate inboard to a point where the crack divides and progresses in two directions around the blade arm barrel. Cracks typically initiate on the forward hub half (opposite side from the engine flange) in the fillet radius closest to the blade leading edge.

Circled areas encompass the "fillet radius", to be inspected at four points on each blade socket.

1. Remove spinner dome.
2. If present, remove any paint\*, grease or other matter which may hinder visual examination.
3. Use 10X magnifying glass to perform careful visual inspection for hairline cracks in the fillet radius area as shown in Figure 1.

5. If there are any indications of a crack, hub replacement (by an approved propeller repair station) must be accomplished prior to further flight.
