Piper Aircraft Corporation  
Vero Beach, Florida, U.S.A.

# SERVICE No. 933A BULLETIN

SUBJECT: Trunnion Replacement

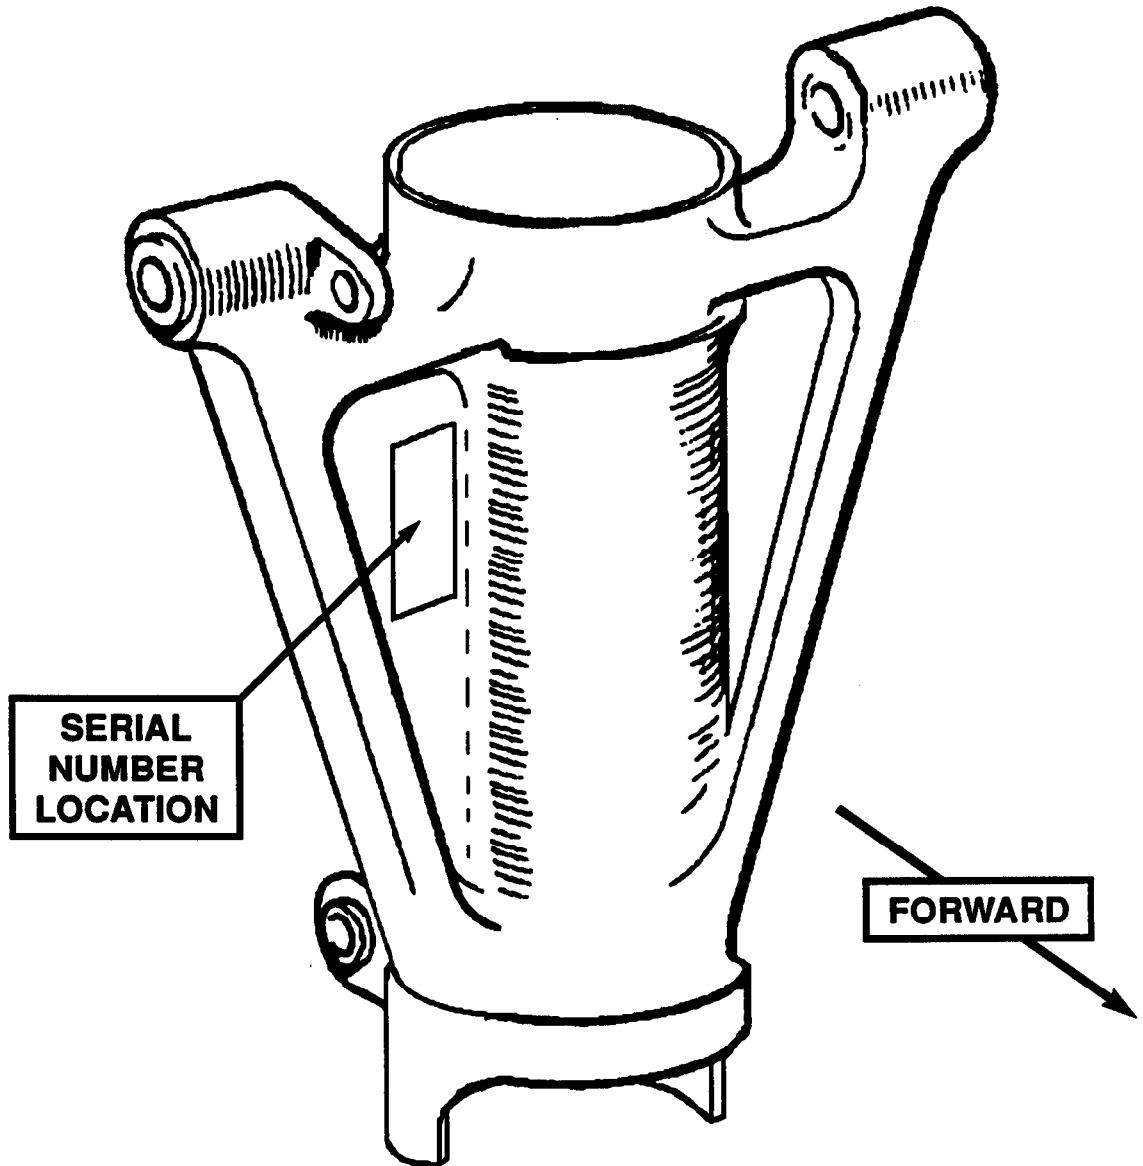
SKETCH "A"

1. Locate serial number etched on the nose gear trunnion. (See Sketch "A") This is located on the front of the trunnion on the left web as you look aft.

2. If the serial number falls between 15200 through 15313, the trunnion must be removed from service. Replace with Nose Gear Trunnion, Piper Part Number 67054-003 with serial number not in the effected range.
3. If the nose gear trunnion requires replacement, place aircraft on jacks and refer to the appropriate Service Manual for instructions and procedures for removal and reinstallation.
4. Following the nose gear trunnion replacement, perform gear retraction cycle check per appropriate chapter of the Maintenance Manual. Upon successful completion, remove aircraft from jacks.
5. Make an appropriate logbook entry of compliance with this Service Bulletin.
