SERVICE *No.* 970 BULLETIN

DATE: April 18, 1994

Defrost System Modification

PA-32R-301 Saratoga II HP

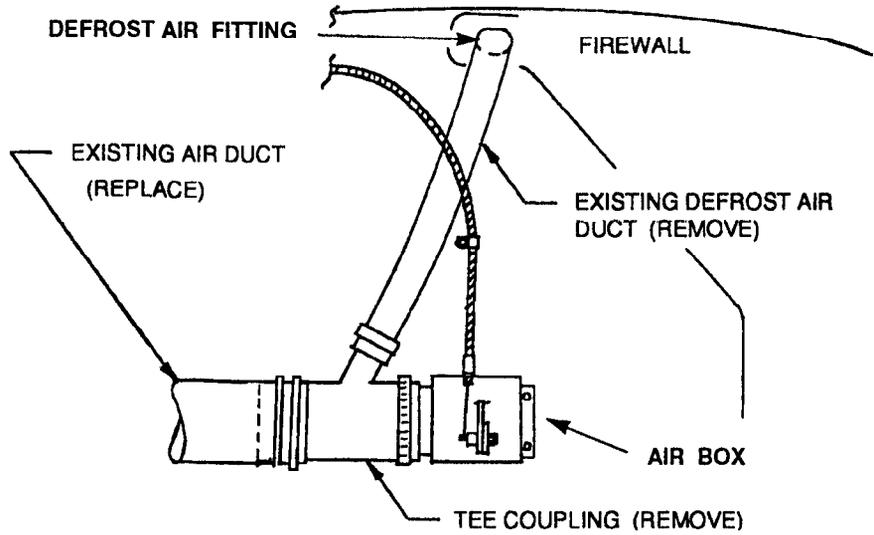
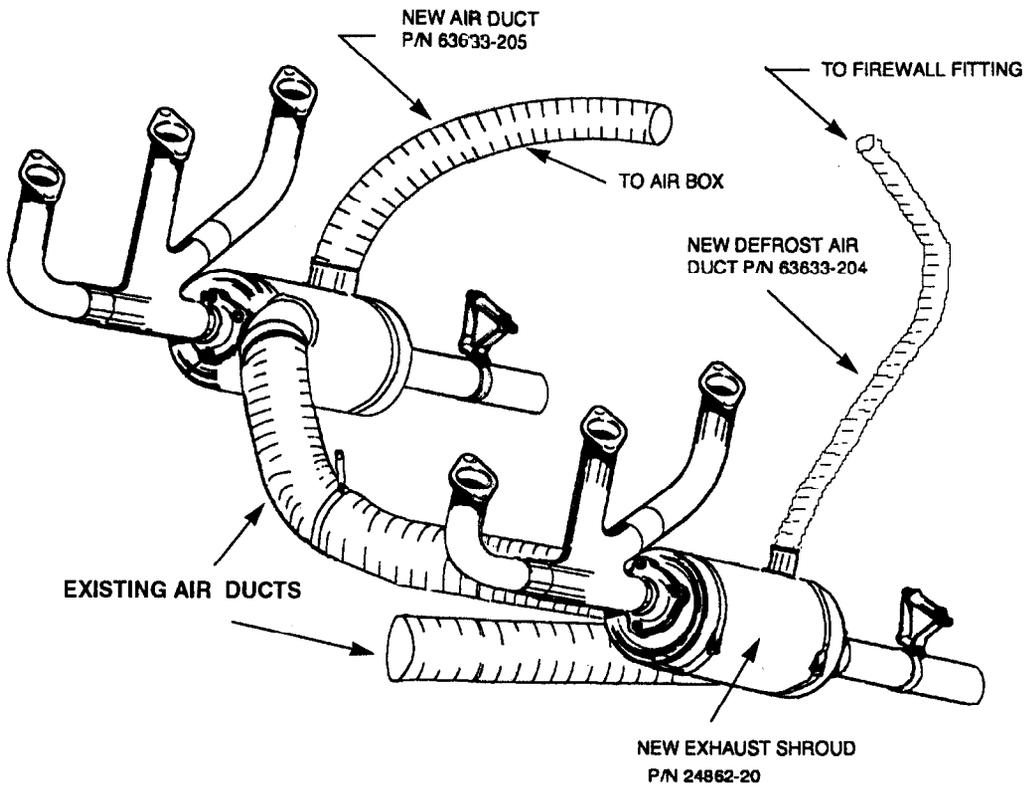
SKETCH A

Reports have been received of excessive heat coming from the defrost outlets when selected. Indications are deformed plastic defrost deflectors on the cowl deck forward of the glare shield and, in extreme cases slight distortions in the co-pilots and/or pilots windshield near the defrost outlet.

5. Disconnect and remove the large diameter flexible air duct on right hand engine exhaust muffler shroud and disconnect the other end of the air duct from the tee coupling for the defrost air duct. Remove the tee coupling from aircraft.

6. Disconnect the two large diameter flexible air ducts on left hand engine exhaust muffler shroud.
7. Remove the existing engine exhaust muffler shroud on the left hand side (pilots side) by loosening the band clamps which hold the shroud halves together.

8. Disconnect and remove the small diameter flexible air duct for the defrost system from the top of the firewall.
9. Install the new exhaust shroud Piper P/N 24862-20 and tighten the band clamps to secure the assembly. Re-connect and secure the two existing large diameter flexible air ducts from Instruction 6.

10. Install the new defrost air duct Piper P/N 63633-204 on the small diameter fitting of the new left hand side exhaust shroud. Route the defrost duct up to the firewall fitting mentioned in Instruction 8. Routing is not critical, however you should be sure there are no kinks or heavy chafing points and that the duct is as close to the firewall as possible. Secure as required.

11. Install the new large diameter flexible air duct Piper P/N 63633-205 on the right hand engine exhaust muffler shroud. Route and secure in the same manner as the removed duct. Connect the other end of the duct to the air box where the tee coupling was removed.
