SERVICE No. 990 BULLETIN

PIPER CONSIDERS COMPLIANCE MANDATORY

Date: January 3, 1996

Pacific Scientific Seat Belt Replacement

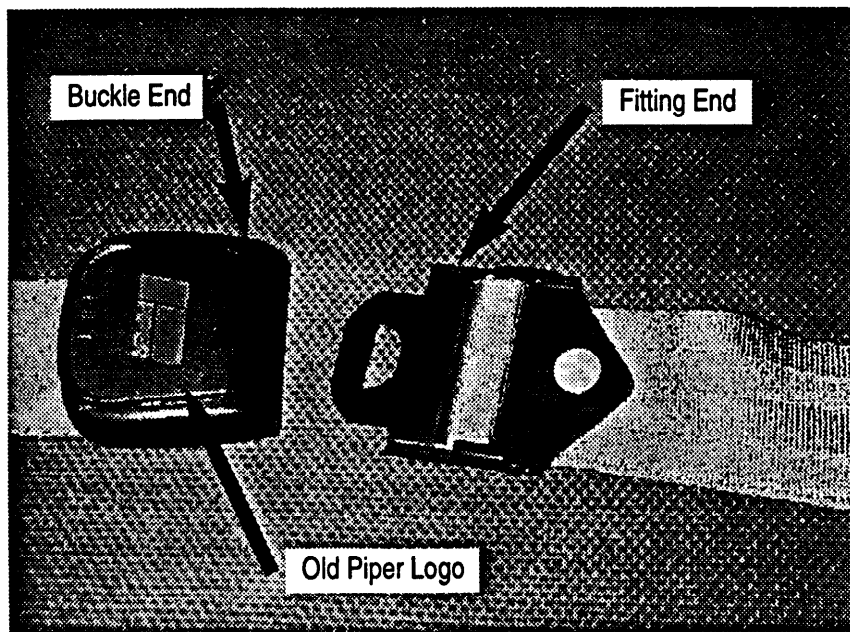
FIGURE 1 (Suspect Belts)

It has been reported that certain seat belts manufactured by Pacific Scientific have experienced difficulty in latching and in some cases would not return to the latched position once opened. The subject seat belts located at all seating positions are affected and must be replaced per the compliance time above. Pacific Scientific has improved the design of the seat belts to preclude the possibility of a recurrence. Left uncorrected the integrity of the seat belt system may be compromised.

2. Determine if the aircraft is equipped with the affected seat belts. Seat belts are affected if they are manufactured by Pacific Scientific and the seat belt has a date stamp of 6/94 through 8/95 (See Fig 2), if the seat belt buckle end has an old Piper logo or no logo (See Figs. 1 and 4.), and if the seat belt fitting end I.D. tag has a date stamp of 6/94 through 8/95. (See Fig 2.)
3. Gain access as necessary to remove all affected belts and replace with new. All improved seat belts will have The New Piper Aircraft, Inc. logo on the buckle end. (See Figs. 3 and 4.) All improved seat belt fitting ends will also have a date stamp on the I.D. tag of 9/95 or later.

4. Check the new seat belts for operation and security of installation.
5. Make an appropriate Logbook entry of compliance with this Service Bulletin.

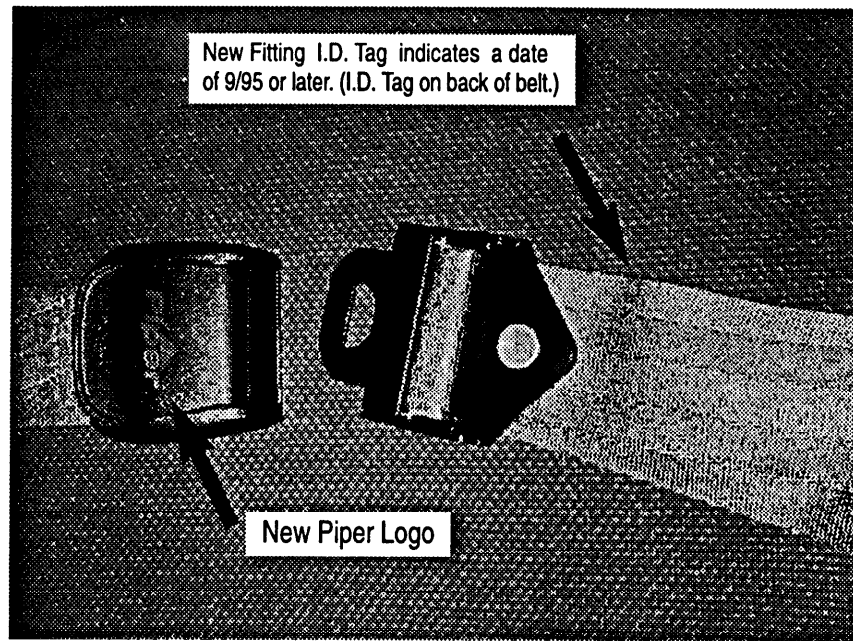
FIGURE 3 (New Replacement Belts)

1. Inspect seat belts at each position in the aircraft. If seat belts conform to the information shown on Fig. 3 no further action is necessary. If the seat belt does not conform, proceed to Instruction 2 (see Figures 1 and 2). If parts are not immediately available or should the aircraft need to be flown to an approved service center, the existing seat belts may be utilized provided the pilot in command inspects each seat belt being used for secure positive latching and that the seat belts are free of any anomalies prior to each flight and during each usage.
