SERVICE No. 1092B BULLETIN

The New Piper Aircraft, Inc.
2926 Piper Drive
Vero Beach, Florida, U.S.A. 32960

Date: April 28, 2003 (S)

ENGINE MOUNT INSPECTION

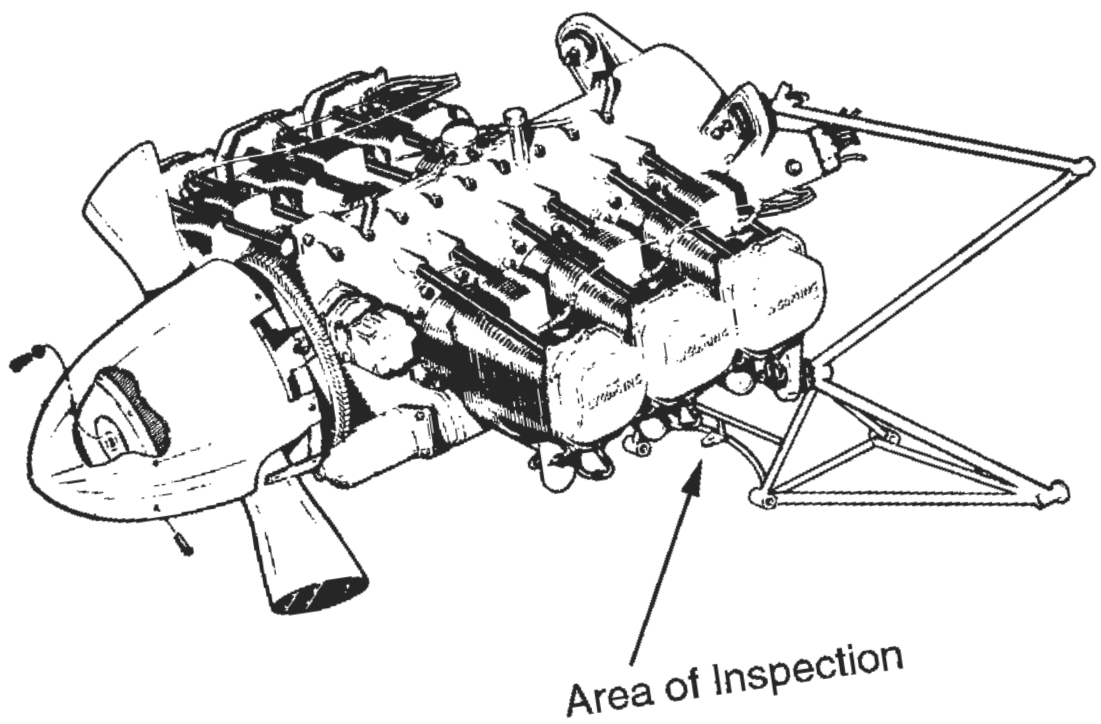
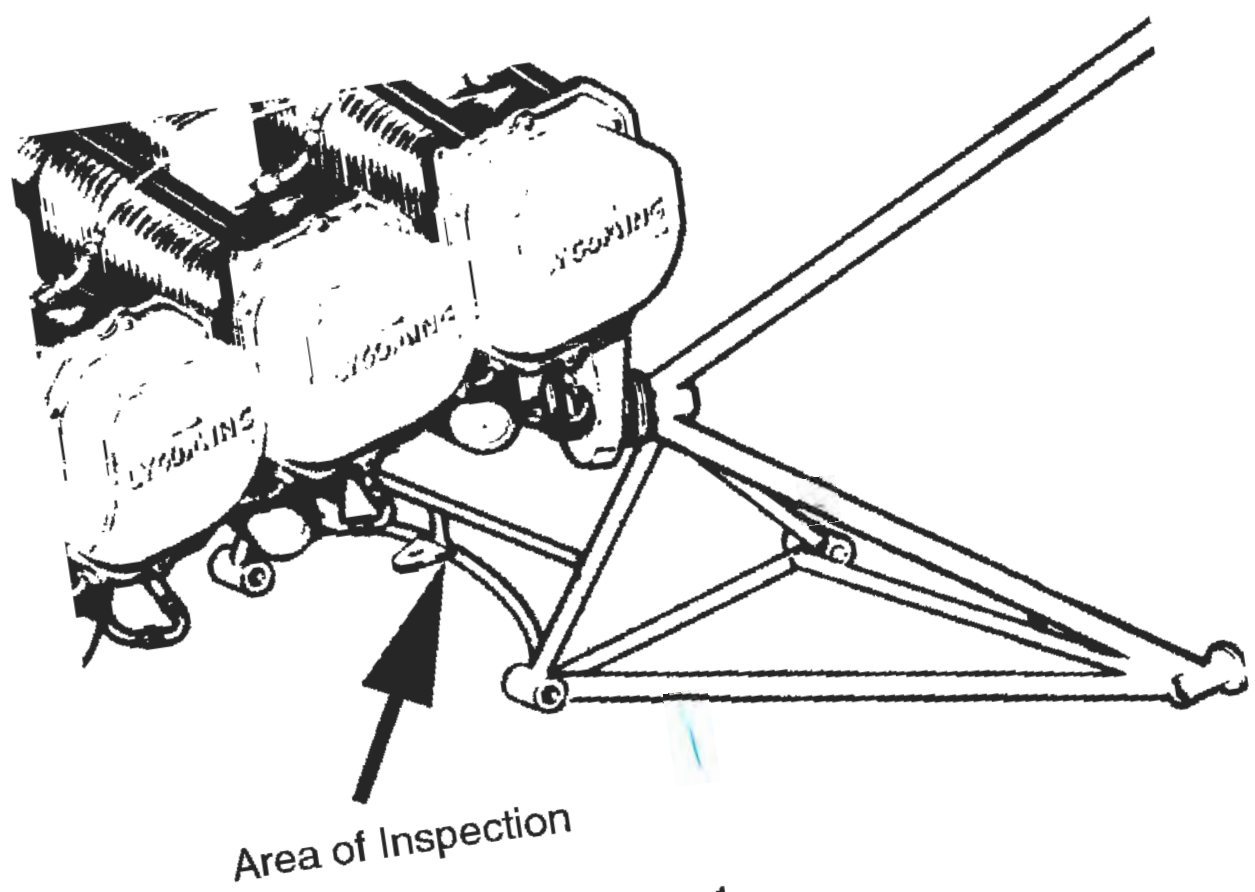
It has been determined that cracks may develop on the engine mount. PART I of this Service Bulletin requires a repetitive inspection of the engine mount.
PART II of this Service Bulletin requires repair or replacement of engine mount.

1. Inspect the engine mount, per AC 43.13-1B in the area indicated in Figure 1 for cracks. Pay particular attention to the weld joint between the short, interconnecting vertical-tube and the lower horizontal tube.
2. If a crack appears in the tube at any point, the engine mount must be repaired or replaced before further flight. The repair of the engine mount per Part II or the replacement of the engine mount with Piper part number 38729-21 or 38729-22 engine mounts constitute compliance with PART I and PART II of this Service Bulletin.
3. If no cracks are found, continue with repetitive one hundred (100) hours time in service inspection per the compliance time above.
