SERVICE BULLETIN

NO. 1216B

Date: September 5, 2012

SUBJECT: AILERON RIB INSPECTION

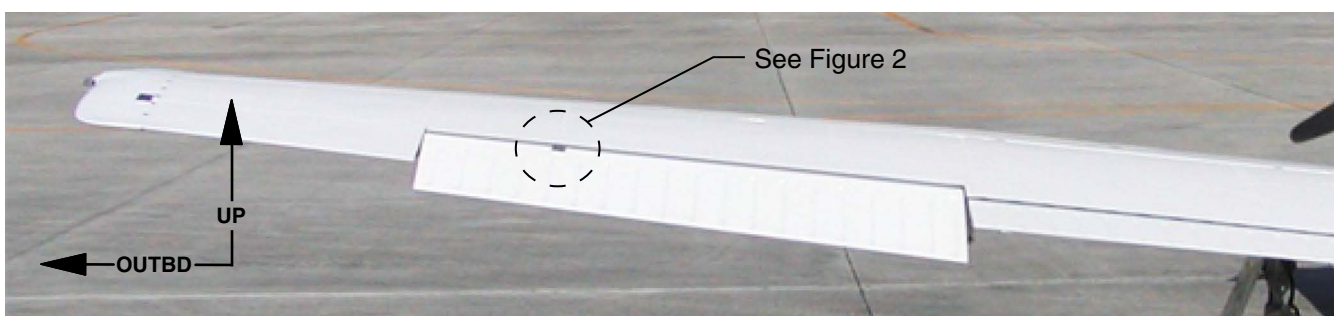
Figure 1

Locate the area of the aileron shown in Figure 1, and examine the hardware that fastens the outboard aileron hinge fitting to the web of the aileron nose rib. (See Figure 2)

Outboard Aileron Hinge Location

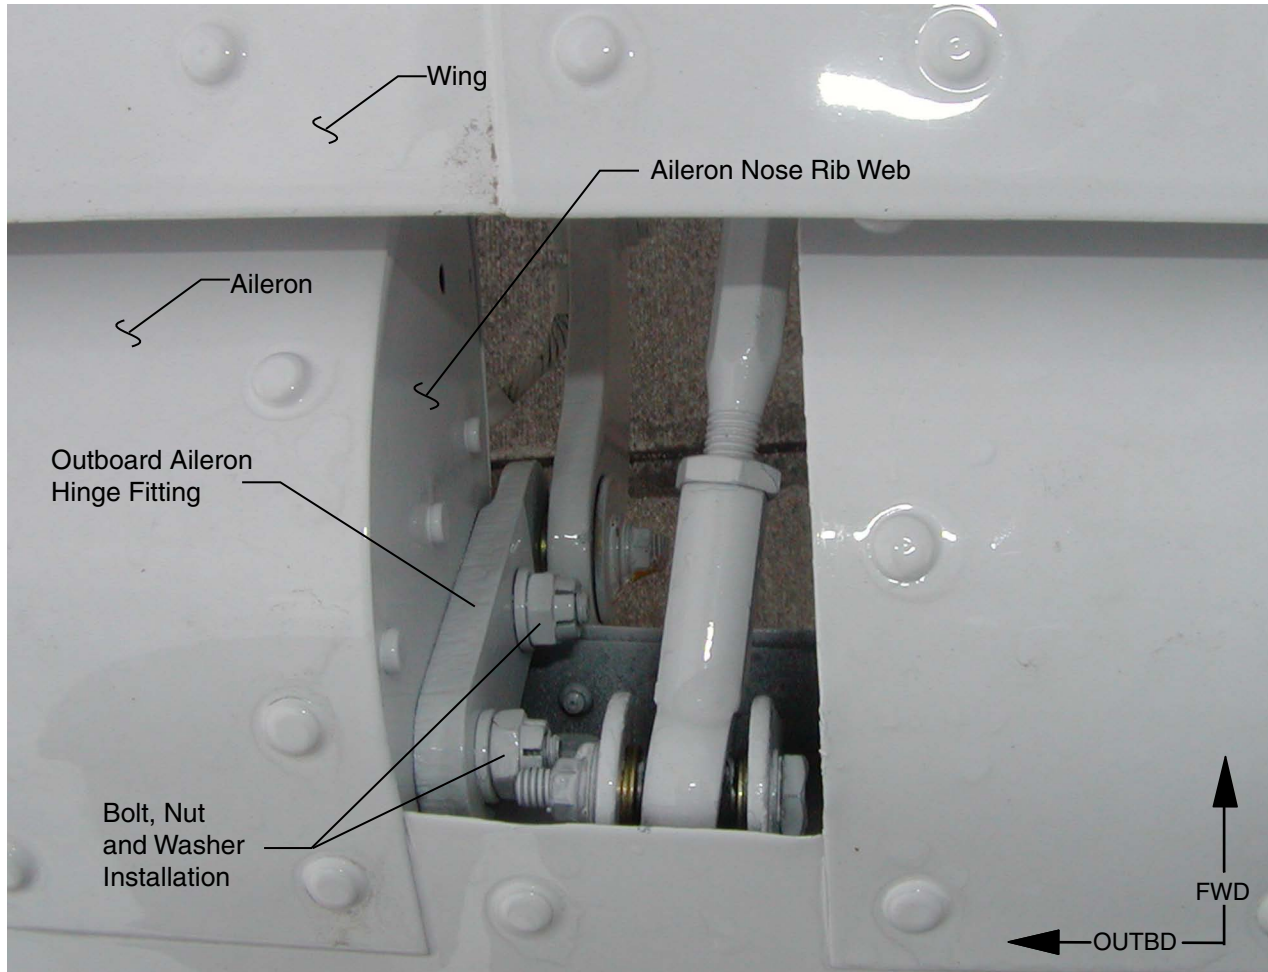
Figure 2

- If nuts are visible, along with a threaded portion of the bolts as shown in Figure 2, the aileron is acceptable for continued use without a recurring inspection or replacement. Proceed to **Part IV** Documentation of Compliance.

Outboard Aileron Hinge Nose Rib Installed With Nuts, Bolts and Washers

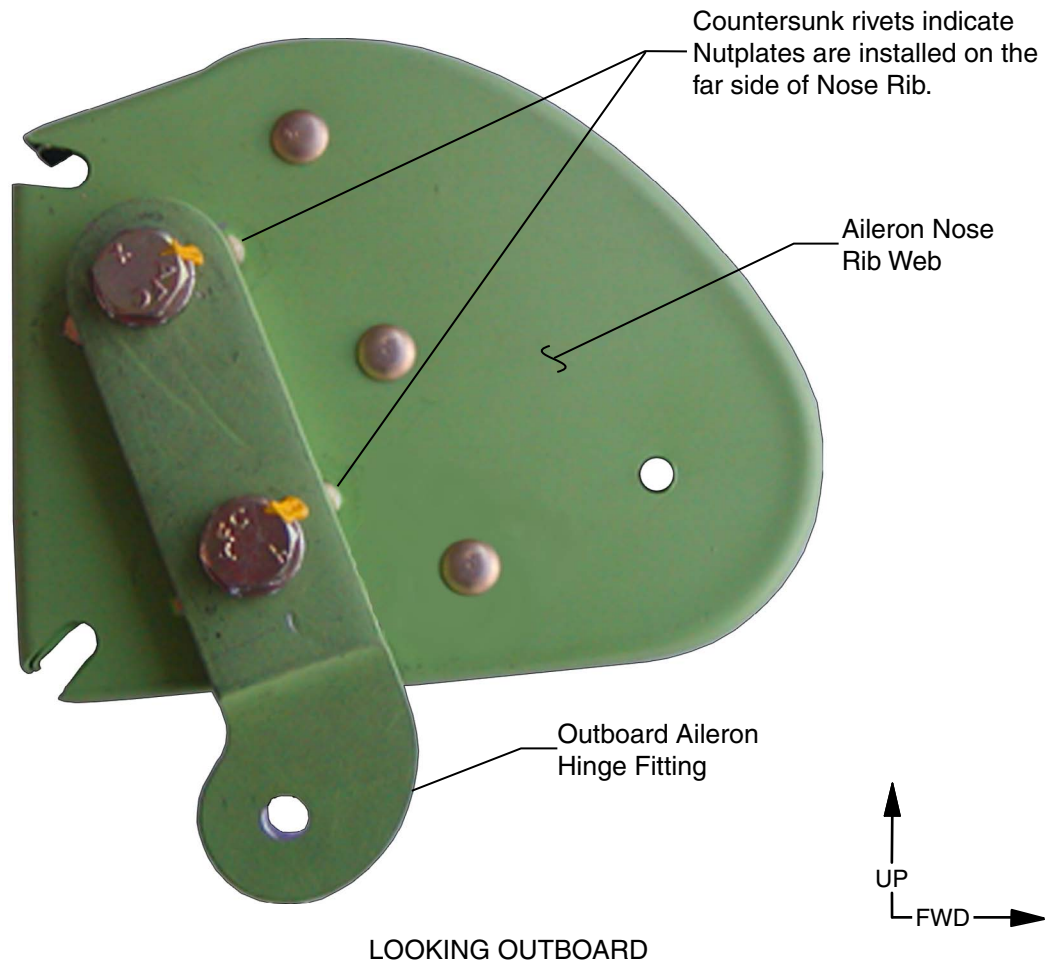
Figure 3
Outboard Aileron Hinge Nose Rib Installed With Nut plate

- If bolt heads are visible, carefully examine the adjacent area of the nose rib web for the presence of countersunk head rivets, as shown in Figure 3. These rivets indicate that a nut plate has been installed on the outboard side (hidden side) of the nose rib web, as shown in Figure 4. These rivets may be hidden by paint. If in doubt, use a borescope to examine the far side of the nose rib web for the presence of nut plates.

- If nut plates are installed on the web of the aileron nose rib, a recurring inspection is required. Proceed to **Part II** Recurring Inspection for Cracks.

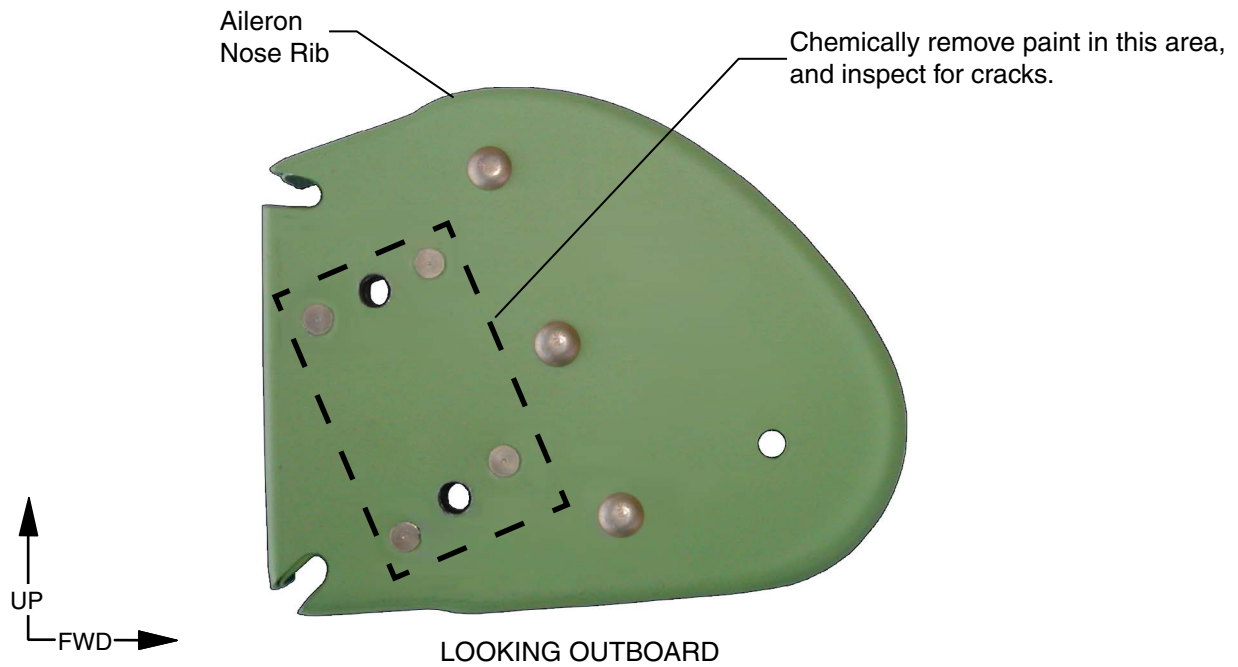
Figure 5
Inspection Area

A service history review reveals that over time, cracks may develop in the aileron nose rib common to the outboard aileron hinge fitting. Left undetected, these cracks may lead to separation of the hinge fitting from the nose rib, resulting in impairment of aileron control.

NOTE: Paint must be removed using chemical processes only. The use of abrasives or other mechanical methods to remove the paint will hide the existence of any cracks, making an accurate inspection impossible. Use isopropyl alcohol to wipe clean the area of the nose rib where paint was removed. See Figure 5.

- d. Perform fluorescent penetrant inspection on the area identified in Figure 5, using procedures described in FAA Advisory Circular AC 43.13-1B.
 - If a crack is detected, proceed to **Part III** Terminating Action.
 - If no crack is detected during the inspection, wipe area of inspection clean with isopropyl alcohol. Apply primer to nose rib in area where paint was removed for inspection using MIL-PRF-85582D Type I Class C2 primer, ANAC 10P8-10 Fluid Resistant Epoxy primer, or any compatible epoxy primer. Apply a compatible top coat of paint such as DuPont Imron, color to match adjacent paint.
- e. Reinstall hinge fitting.
- f. Reinstall aileron.
- g. Proceed to **Part IV** Documentation of Compliance.

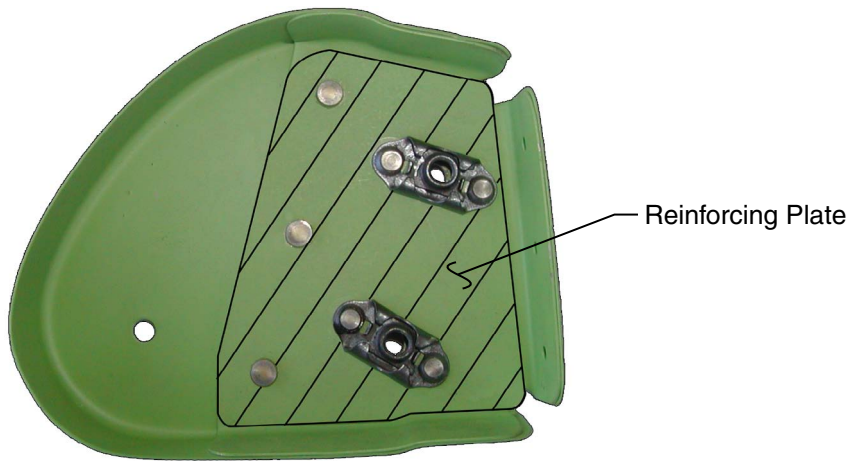
Figure 6

NOTE: New, replacement Ailerons, Piper P/N 38650-007 (right side) and P/N 38650-008 (left side) and new replacement Outboard Aileron Nose Ribs, Piper P/N 86398-009 (right side) and P/N 86398-008 (left side) feature a reinforcing plate installed between the rib doubler and the nutplates. This reinforcing plate can be identified by carefully examining the aileron nose rib from either the inside or outside surfaces. This reinforcing plate is designated by the cross-hatched areas shown in Figures 6 and 7. Note that figures 3, 4, and 5 show aileron nose ribs without a reinforcing plate. Aileron nose ribs with the reinforcing plate do not require a recurring inspection.

Outboard Aileron Hinge Nose Rib With Reinforcing Plate

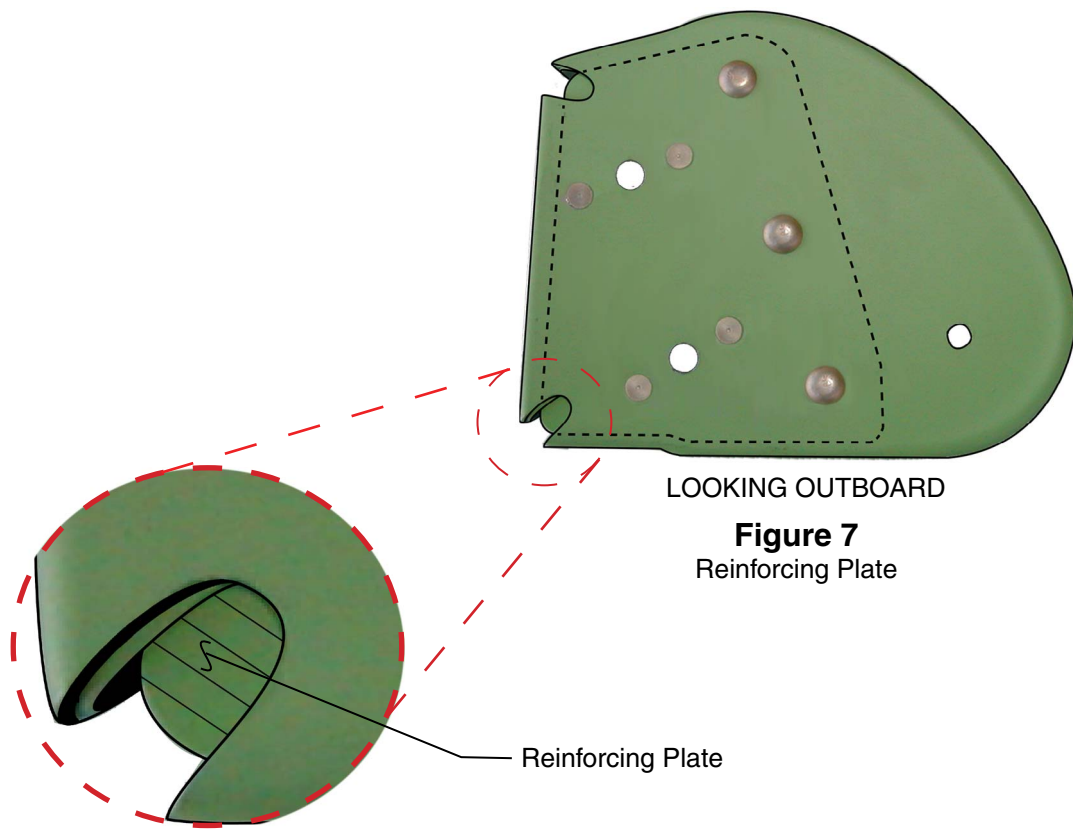
Figure 7

Reinforcing Plate
