## VENDOR SERVICE PUBLICATION

**SUBJECT:** LYCOMING SERVICE BULLETIN NO. 625

# MANDATORY SERVICE BULLETIN

SUBJECT: Alternator Fan Backplate

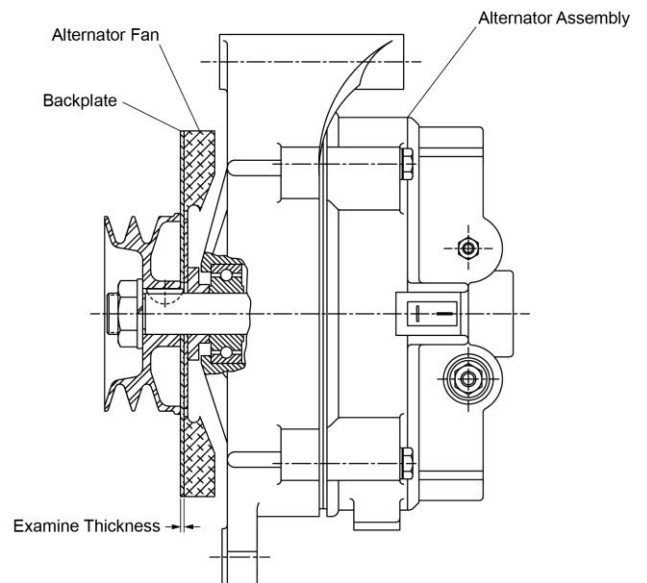
Figure 1  
Alternator Fan Backplate

This Service Bulletin is notification of a requirement to replace specific alternator assemblies identified herein as a corrective action for potentially non-conforming alternator fan backplates in the field. Continued operation of an alternator with a non-conforming alternator fan backplate can cause undue flex and stress on the backplate during engine operation.

1. Identify and remove any alternator assembly identified in Tables 1 or 2 from all of your affected Lycoming engine models identified above or in inventory.
2. Examine each suspect alternator assembly (Figure 1) for the correct alternator fan backplate thickness of 0.052 to 0.072 in. (1.321 to 1.829 mm) instead of 0.027 to 0.044 in. (0.686 to 1.118 mm).

3. If the alternator assembly has a fan backplate thickness measuring less than 0.052 in. (1.321 mm) follow the warranty instructions in this Service Bulletin.
4. Show compliance to this Service Bulletin in the logbook of each affected engine by recording the serial number of each returned non-compliant alternator assembly and the serial number of the replacement alternator. Also, record notes in your inventory records of compliance and findings in your spares inventory.
